PanAfGeo

WP-E GEOHAZARD AND ENVIRONMENTAL MANAGEMENT OF MINES

KIGALI, RWANDA, 19TH – 25TH NOVEMBER 2023

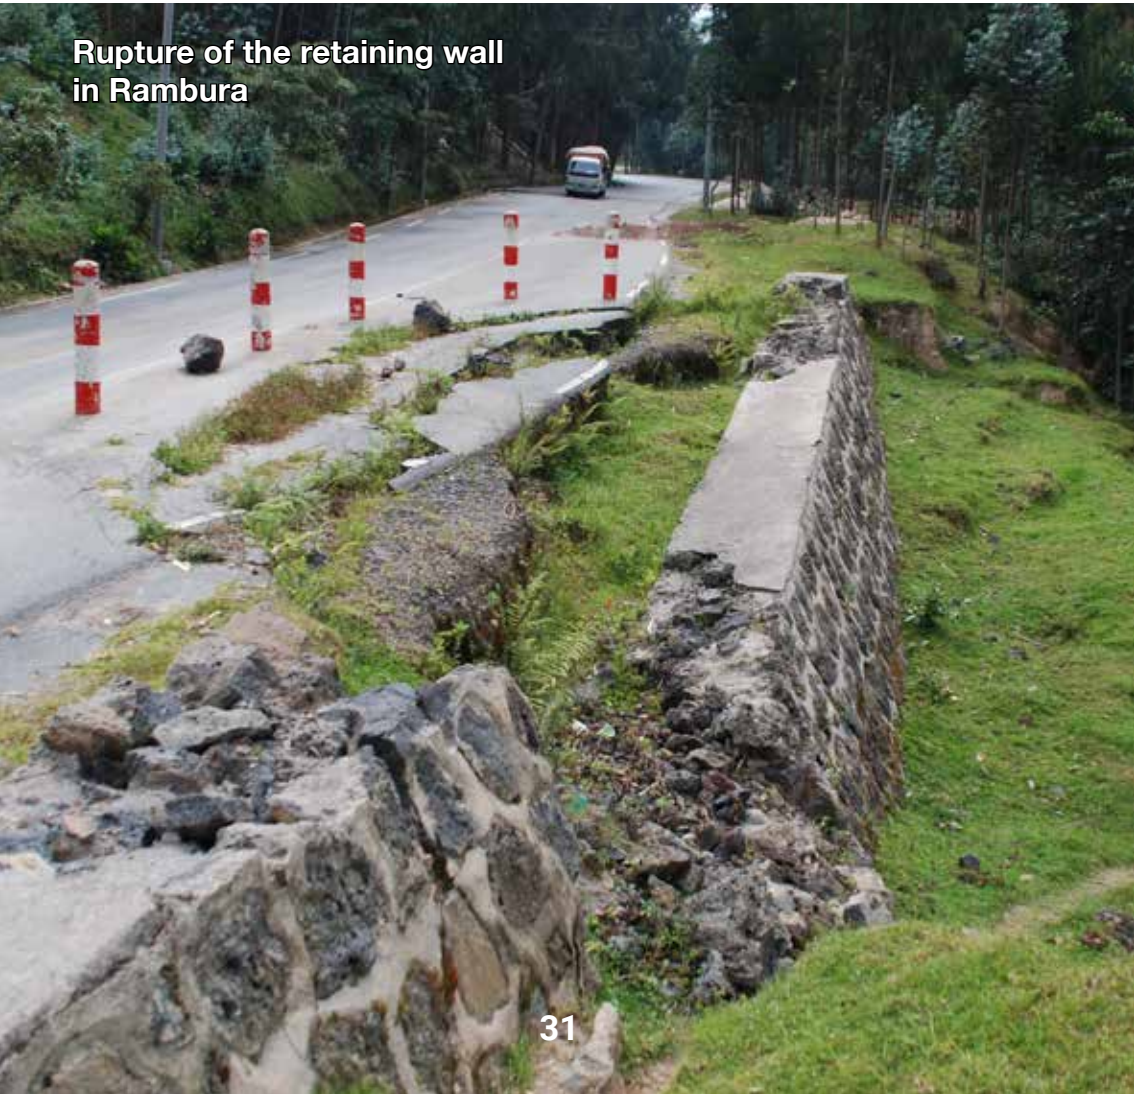
Rupture of the retaining wall in Rambura

The mass movement of stop 5 involves a ca. 50 m road sector located approx. 1,500 m east before the village of Rambura. A multi-temporal analysis was performed with Google Earth® images taken from 2017 to 2020. Similarly to the landslide of stop 4, the failure (rotational) was caused by river erosion at the slope toe. In this stop, a geomorphological

assessment of the area will be discussed along with an analysis of typology, design and long-term effectiveness of the structural interventions recently built on the road side and slope toe.

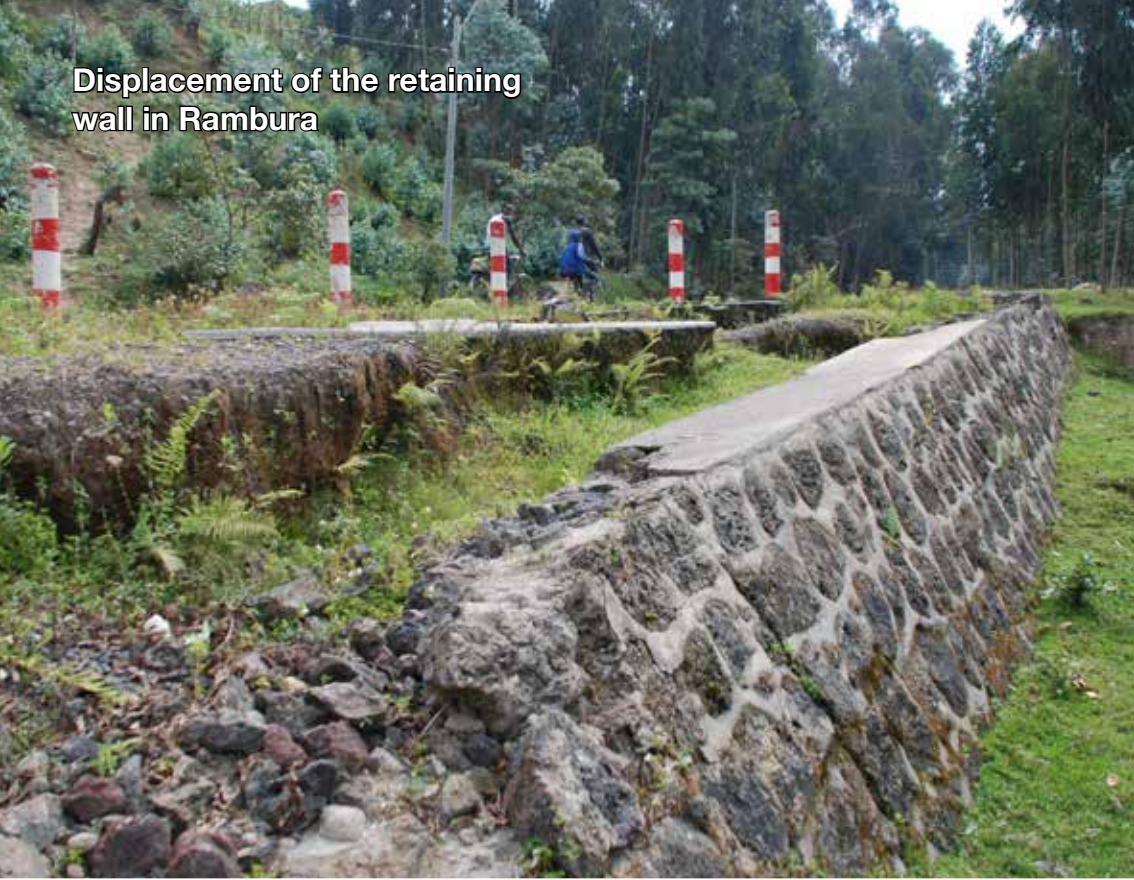
Displacement of the retaining wall in Rambura

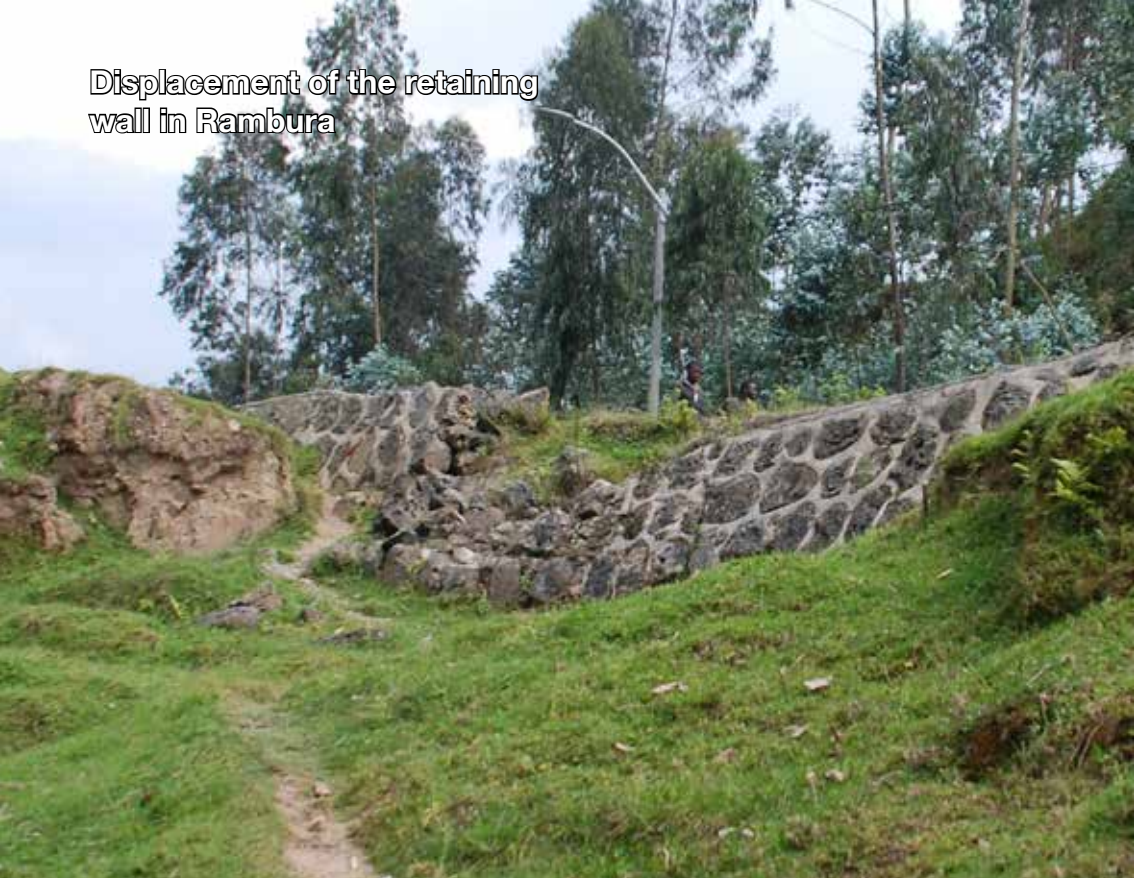
Displacement of the retaining wall in Rambura
