PanAfGeo

WP - E Geohazards and Environmental Management of Mines

Blantyre, Malawi, 7th - 12th November 2022

Field Trip Guide

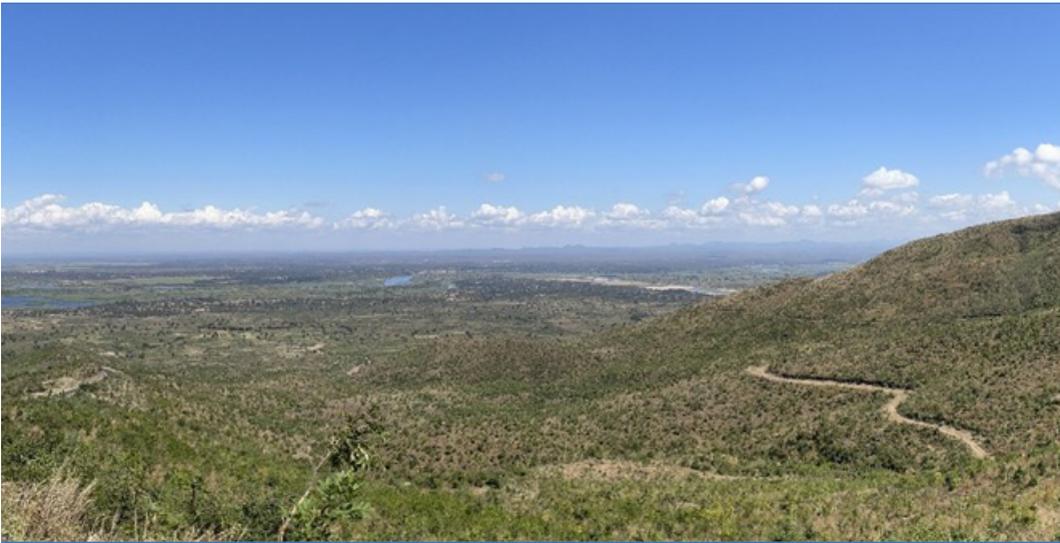
Figure 4 - The Shire River Valley, viewed from the Thyolo Fault escarpment

The actual Shire River Valley (Figure 4) is a low relief area forming a plain that is defined by the Thyolo fault (Figure 5) escarpment to the north and north-east. It is commonly affected by floods almost each and every rainy season. The Shire River is the most important river in Malawi. The Shire River is 250 miles (402 km) long and issues from the southern shore of Lake Malawi, of which it is the only outlet. It enters Lake Malombe (q.v.) 5 miles (8 km) south of Mangochi and exits to flow through swampy banks flanked by the Mangochi Hills and the Zomba Mountain scarp to the east and the Chiripa Plateau to the west. The Shire then enters its narrow middle valley. Between Matope and Chikwawa, it drops 1,260 feet (384 m) through 50 miles (80 km) of gorges and cataracts, falling successively over Kholombidzo (formerly Murchison) Falls, Nkula Falls, and Tedzani Falls, through the Mpatamanga Gorge, and over Hamilton Falls and Kapichira (formerly Livingstone) Falls. Dams at Nkula Falls and Tedzani Falls, northwest of Blantyre, harness the river's waters for hydroelectric power. Below Chikwawa, the river enters a wide marshy extension of the Mozambique coastal plain, the only area of Malawi below an elevation of 500 feet (150 m). The Lower Shire River valley's borders are distinct only to the northeast (the Cholo Escarpment) and the southwest (the Nsanje Hills). The chief tributary, the Ruo River, joins the mainstream in the lower val-

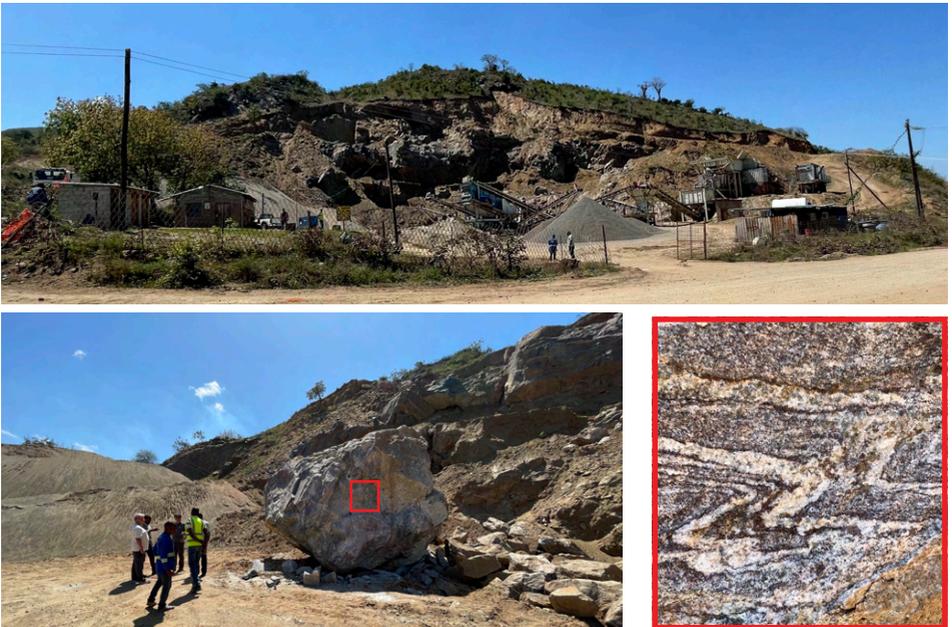
Figure 6 - Thabwa Quarry

The Quarry is located just at the edge of the Thyolo fault scarp at Thabwa area, a few meters east of the Thabwa Roadblock at on the Blantyre-Chikwawa Road. In the quarry, the excavated rock material is used as aggregates for concrete or road foundations. The rock is mainly composed of gneiss which is extracted with the use of explosive and further crushed in the plant located inside the quarry. The type of rocks being mined at this site are Biotite gneisses. The geology around Stop 3 and 4 is similar to Stop 2 i.e., mostly characterised by weathered biotite gneisses. Both

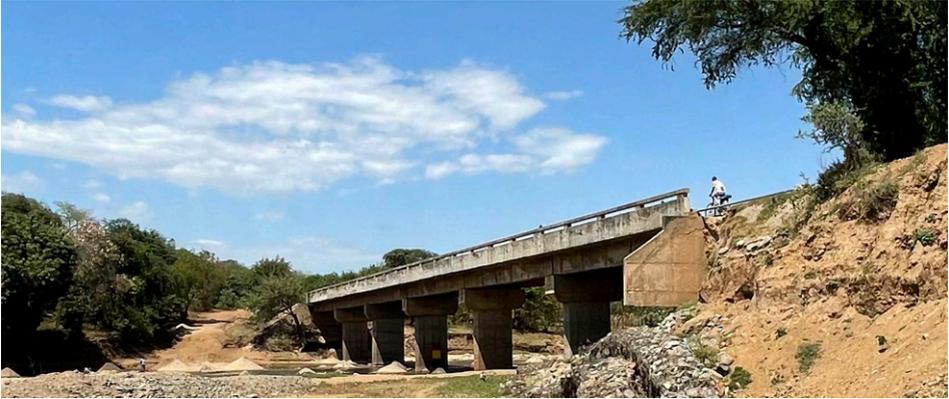
Figure 9 - The Mwamphazi bridge

From an engineering point of view, the bridge is a reinforced concrete structure characterised by 5 pylons (Figure 9).

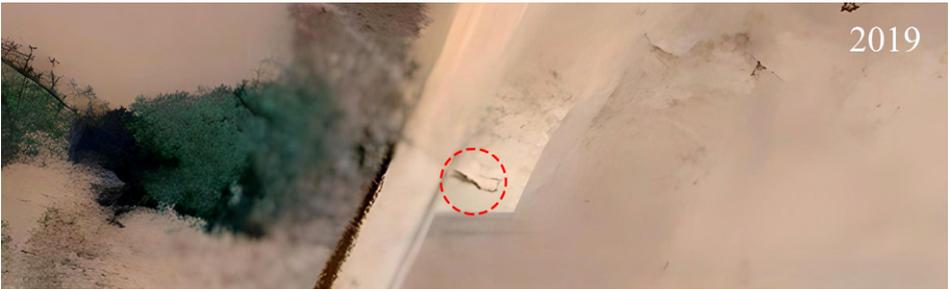
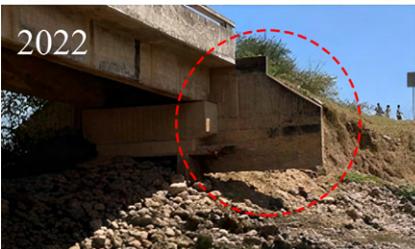
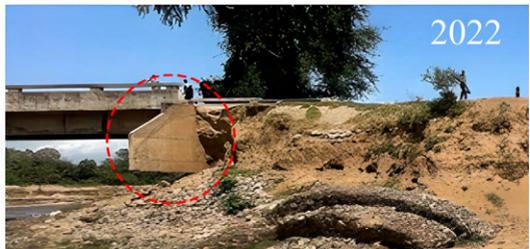
Figure 10- River erosion at the Mwamphazi bridge

The right bank abutment was reinforced with stone gabions to protect the abutment and the upper road from the river erosion. The gabions were likely placed over a concrete superficial platform, clearly visible in the aerial images from 2019 (circle in Figure 10). Presently, the gabions are damaged and no longer work as a protection for the bridge/road system.

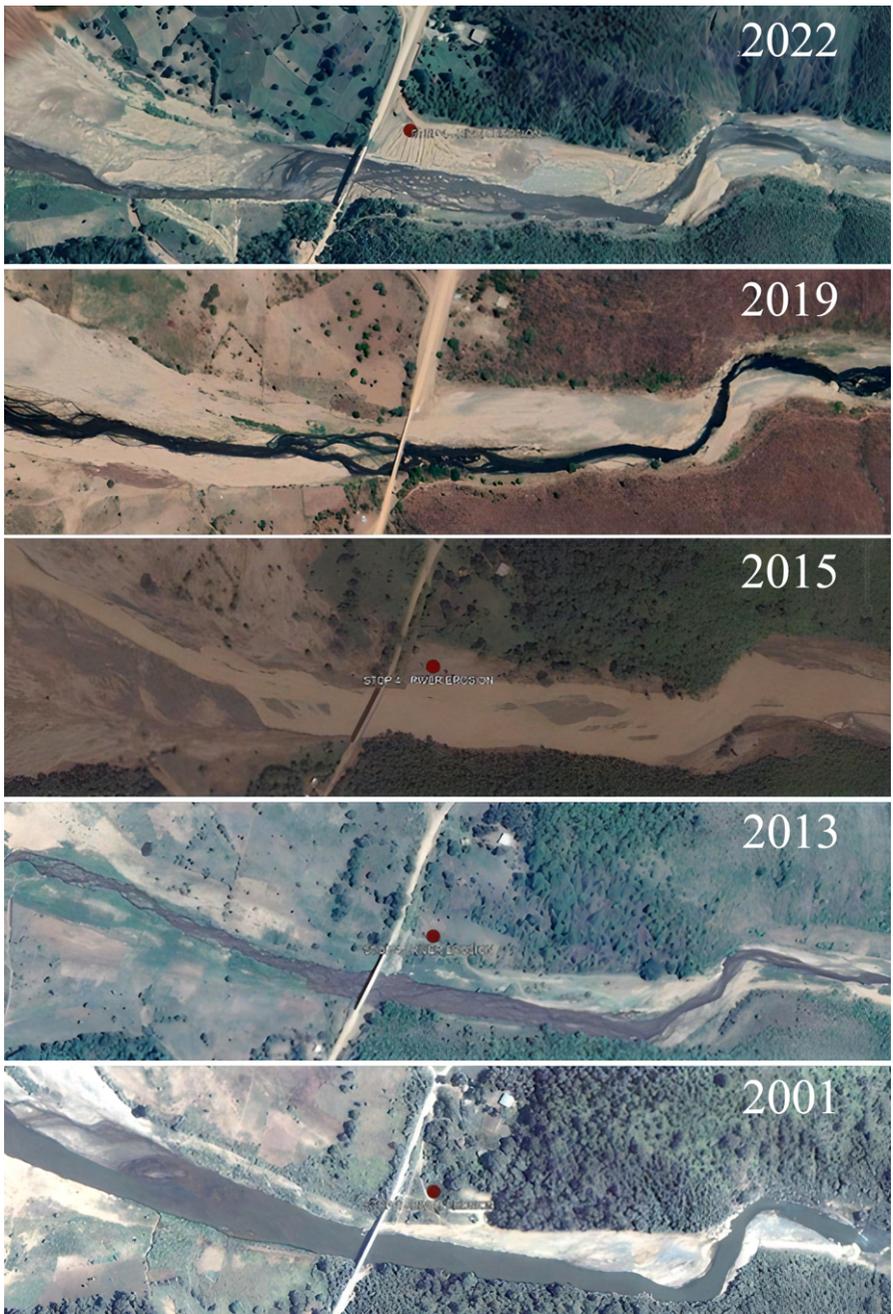
Figure 11 - Multi-temporal analysis images from 2001 to 2022 (Google Earth®)

A simple multi-temporal analysis by using Google Earth® images from 2001 to 2022 (Figure 11) helps understand the fluvial dynamics and local geomorphology, uphill and downhill the bridge location.

The analysis of the images provides some good indications on local fluvial dynamics. The river presents a general straight trend after an abrupt bend uphill the bridge. In that area, the erosion of the left bank is clearly visible as well as a general trend to soil

deposition in the right bank. The flood plain, mostly covered by vegetation, is well visible in the 2001 image. The vegetation progressively disappears in the last decade. The area is being interested by excavation and exploitation of sand, used mainly for construction purposes. The effects of human exploitation of the area are well detectable in 2022 image. Some conclusions of this brief analysis are the following:

- The effect of damage on the Mwamphazi bridge are quite evident and temporally attributable to events occurred mostly in the last decade,
- The local river geomorphology has changed mostly due to human interventions on local flood plain since the natural flow dynamics, also during seasonal flood events, cannot likely justify the magnitude of the structural damage of the bridge,
- Such human effects can be resumed in progressive deforestation of the right riverbank and excavation of the river bottom, especially around the bridge area,
- Anthropogenic actions have produced an acceleration of the river erosion due to increase of the local river bottom slope (and increase of flow velocity) and lack of vegetation which generally acts in reducing erosion and water flow velocity during flood events,
- Erosion effects have mostly affected

the river right bank where the road embankment is creating a dam effect during flood events.

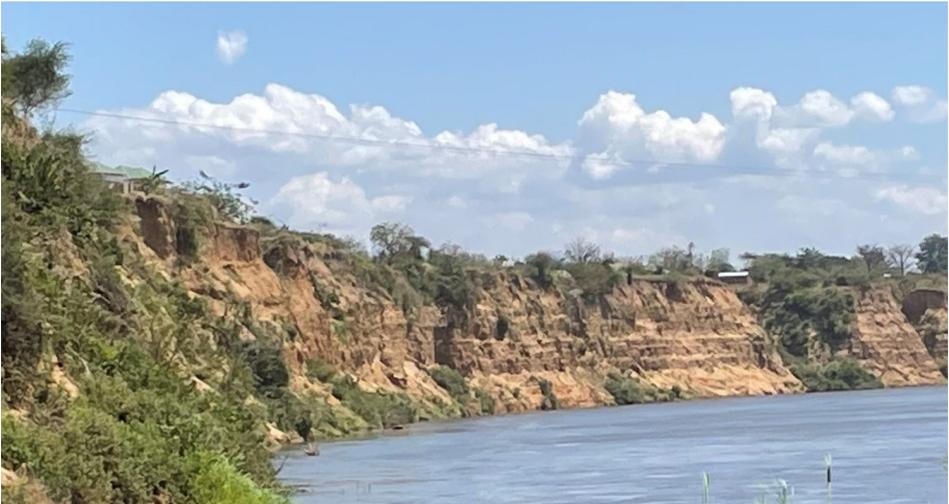
Figure 12 - Erosional surface (up) as viewed from Kamuzu Bridge (down) on Shire River

Stop 5 is an exposed profile within Shire River where bank erosion has steeply eroded the banks of this river (Figure 12). The eroded profile on the banks of this river exposes a thick superficial layer (sediments).

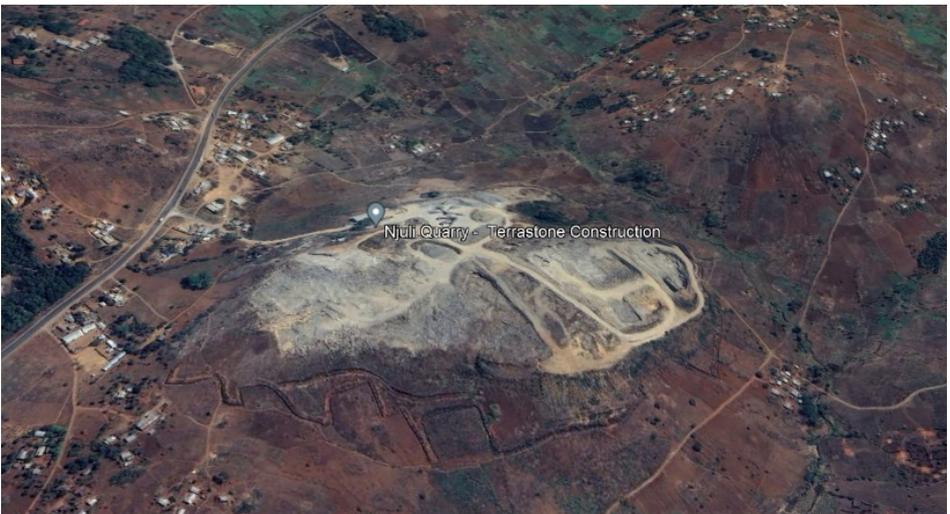
Figure 15 - Aerial view of Njuli Quarry Mine for rock aggregates (Google Earth®)

The Njuli Quarry (Figure 15) is located approximately 30 km NE of Blantyre. The outcropping rock at this site is made prevalently of Charnockitic Granulites that are being exploited as construction materials. Inside the quarry, a steep slope formed by jointed rock material outcrops and represents a very good example to implementing a rock mass characterization. As discussed in the class lecture on engineering geological methods applied to rock mass analysis and stability, discontinuities control the mechanical behaviour of rock masses along with other elements such as circulating waters, type and geotechnical characteristics of the rock, slope geometry, etc.

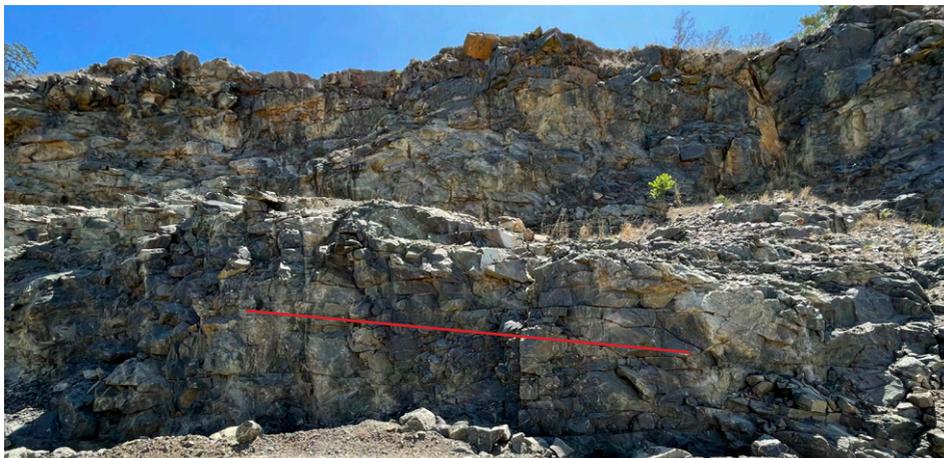
Figure 17 - Scanline in the rock slope outcropping in the Njuli Quarry

Implementation of a scanline (Figure 17) which intersects the main sets of discontinuities (i.e. faults, joints, main fractures, bedding planes) and Measurement of a discontinuity plane with a structural compass (Figure 18).

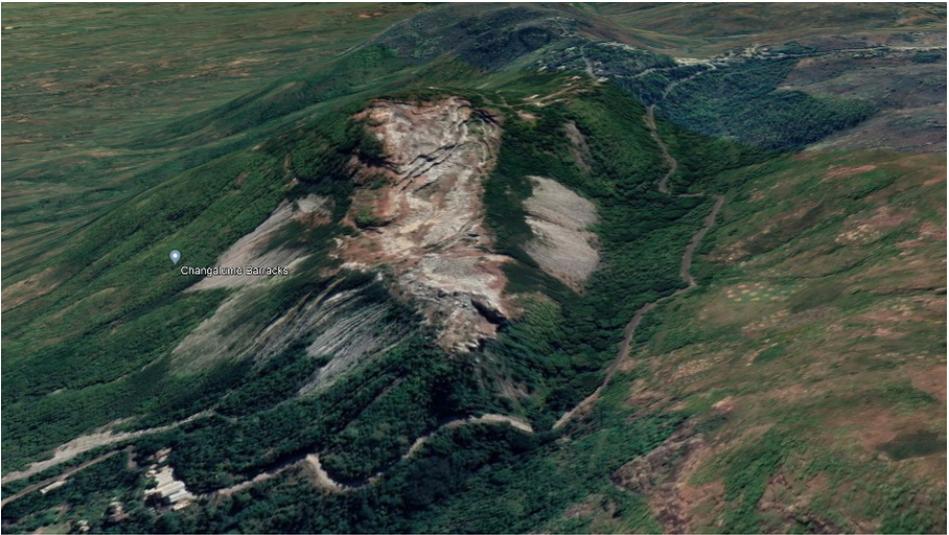
Figure 22 - Aerial view of Old Chungalume Marble Mine (Google Earth®)

The Basement Complex paragneisses and charnockitic granulites outcrop over about a third of Zomba area, the remaining one third is covered by colluvium. Within the Chungalume area the outcropping rocks are dominated by a marble that forms the Chungalume Hill (Figure 22), the marble at this site ranges in colour from white to grey or pink with a granular to saccharoidal texture.
